Edinburgh Castle Development Proposal

Jamaica National Heritage Trust

**World Heritage Unit,
Archaeology Division**

July 2010

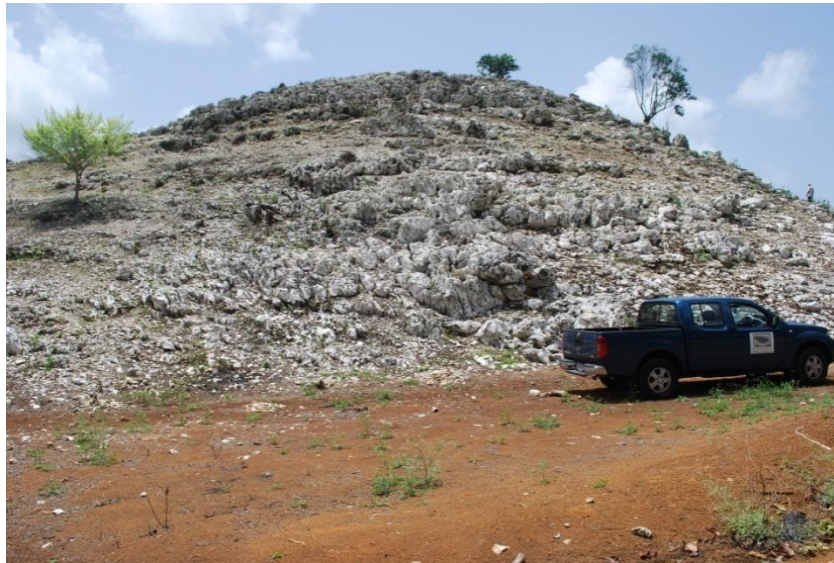
In assessing the Edinburgh castle site there were several observations noted. The site is located in the Pedro district of St. Ann on a low hill near to the main road. The hill is made up of mainly limestone rock and has vegetation sparsely distributed around its surface (**Plate 2**). There are also many stones on the hill (**Plate 3**).

Plate 2. View of the limestone hill showing sparse vegetation

Terraces for planting small gardens could also be created on the exposed hill to add beauty to its current starkness as well as to reduce soil erosion (**Plates 44 & 45**). This would go around the hill's entire circumference. Terracing can be carried out as a part of the long-term plan for the property.

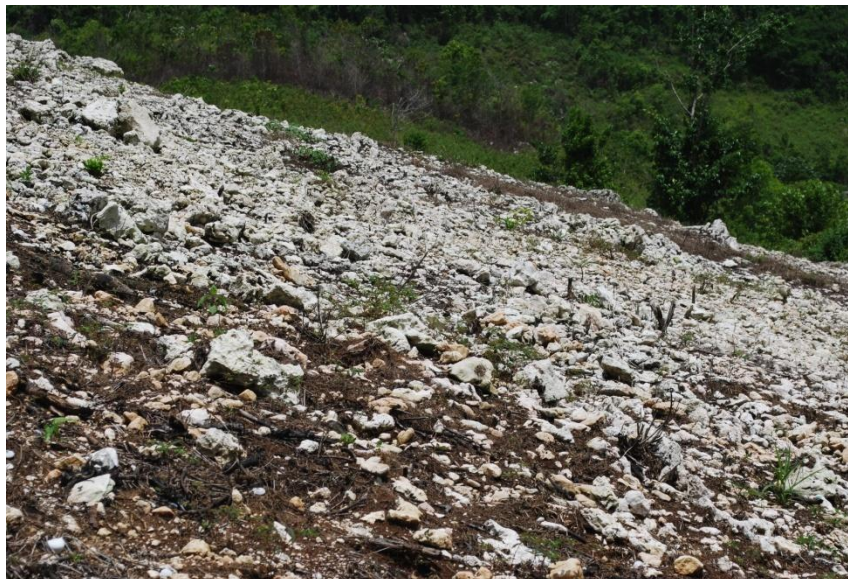
Plate 3. View of the limestone hill showing loose stones

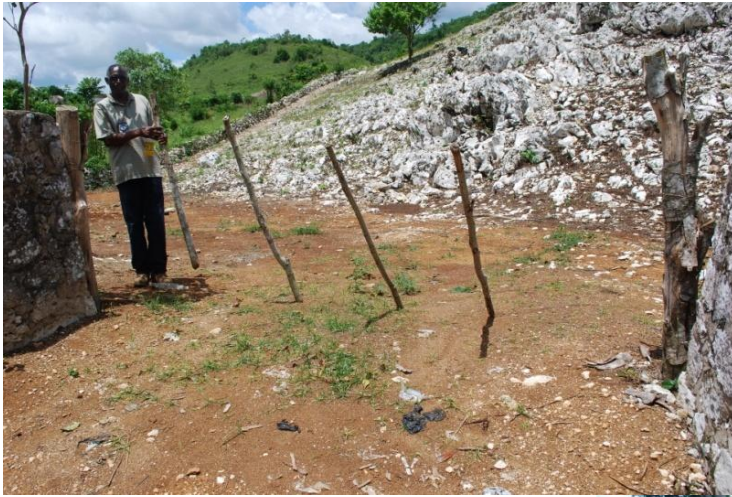
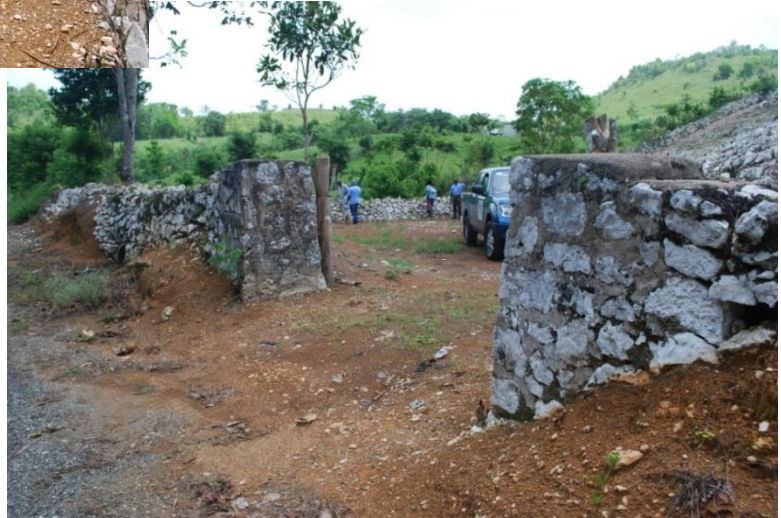
The entrance to the site is through a narrow gate consisting of wooden posts and barbed wire (**Plates 4 and 5**) and access through the entrance proved to be difficult for vehicles.

Plates 4 &5. View of gate from main road

The access road to the site is in good condition. However, the right entrance gate should be widened or extended 1 to 2 meters to allow for entry of large vehicles on the property such as tour buses. An iron gate (Plates 29 & 30) should be placed at the entrance to the site to replace the current wooden and barbed wire gate.

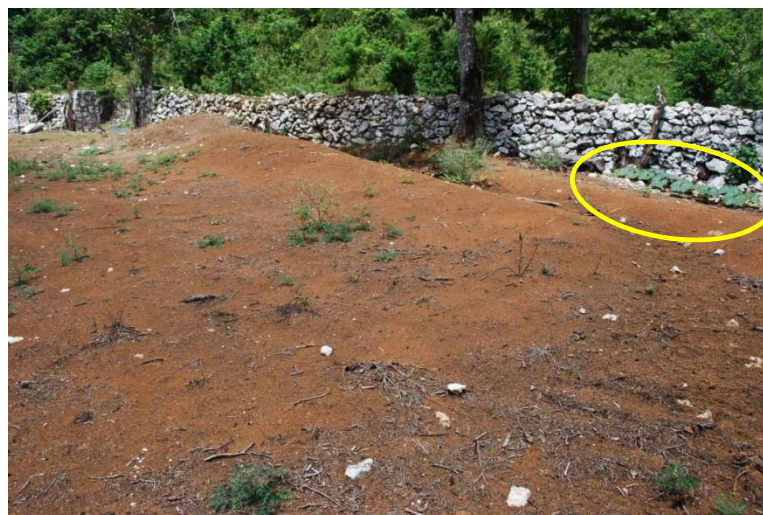
The surface at the foot of the hill on entering the property is very uneven and does not provide much space for parking. This area also does not encourage exploration due to its uneven surface. In addition, there is a pumpkin vine planted near to the boundary wall in this area (**Plate 6**).

Plate 6. View of pumpkin vine

this area, to facilitate parking for patrons while adding the softening of site with grassy sections. The grassy areas around the base of the hill could also be linked and grass and other plants be planted around large trees and stones along the walking paths. The pumpkin vine would also be removed in this landscaping process.

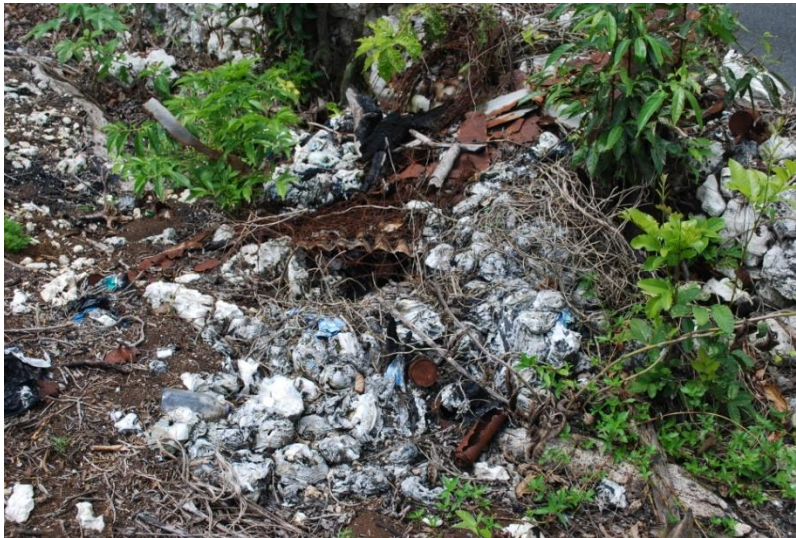
Also observed in this area specifically to the left of the entrance gate, rubbish has been dumped and some has been burnt while other pieces have been left as litter (**Plate 7**). There is in this area, a small alcove where some of the plant-life specifically trees has been removed (**Plate 8**). This section also leads to an area where there is evidence that farming has taken place as yam, banana and papaya plants were observed (**Plate 9**).

Plate 7. View of rubbish heap including rusty fragments

There are several plants and overgrowth on right side of the boundary wall both on the inner and outer section of the property that needs to be cleared. In the area where rubbish has been dumped, it needs to be cleared of all debris.

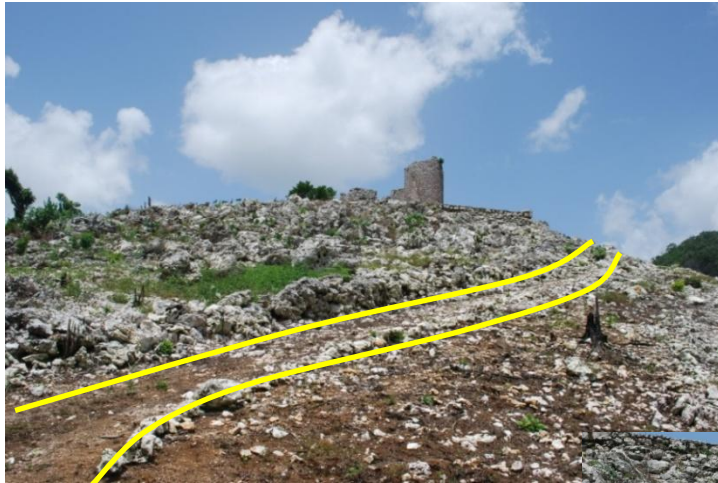
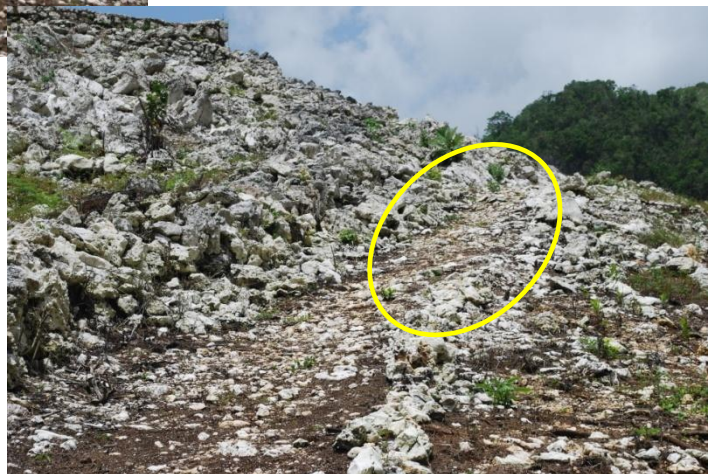
The castle structure is located at the top of the hill and access is gained along a rocky uneven path which travels from the base of the hill to the castle itself. The path has many loose stones and soil at the first section with larger rocks at the top. This unevenness has the potential to cause injury to persons attempting to access the castle via this path (**Plates 10 & 11**).

Plates 10 &11. Showing views of pathway leading to castle

The first section of the walkway towards the castle consisting of mostly soil and loose stone should be fitted with wooden beams (**Plates 33 & 34**) as trail steps, to allow easier access to the site and also to prevent washing away of the top soil along the walkway. The trail steps would consist of a combination of gravel, rough paving stone and wood. The stone, gravel and paving stone could be added to create a more solid substrate which would then be compacted and

the wood would act as a retainer to prevent the material washing away. It is important that to reduce slipping when there has been rainfall that the wood be also be rough and not too smooth allowing for a better grip. The section closest to the top of the trail has more stone than soil and steps could be created.

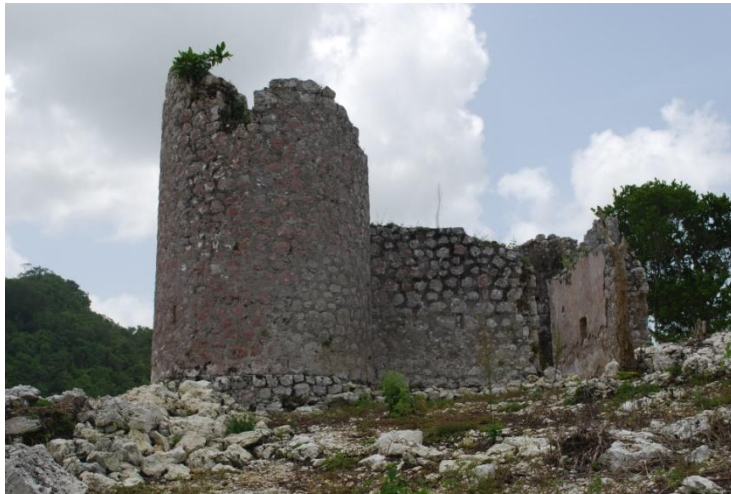
The castle structure is aptly described as a ruin. It shows evidence of trees and shrubs growing out of the walls at the top and within the main body of the castle (**Plates 13 &14**). In addition, tree roots were observed growing along the wall of what seems to be the chimney from the fire place (**Plate 15**).

Plate 13. Showing vegetation growing from the top of the of the castle

All weeds, small trees and roots that are currently protruding from and growing within the structure should be removed with the assistance of the Conservation Unit. For the areas that exhibit cracks in the walls, these areas should also be restored by filling as soon as possible to prevent any further deterioration of the structure.

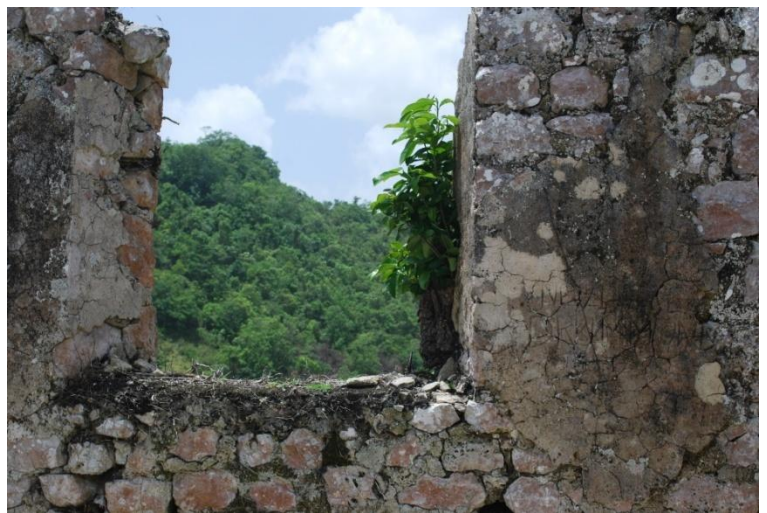
Plate 14. Showing vegetation growing from the walls of the castle

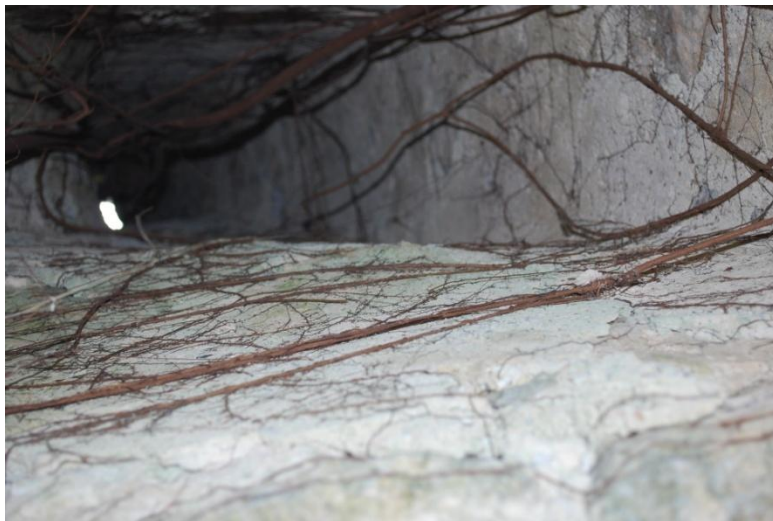
Plate 15. Showing roots growing from the top of the of the structure

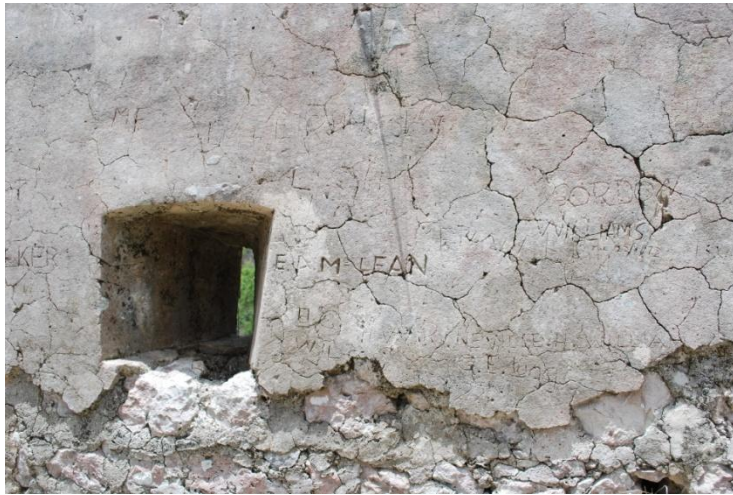
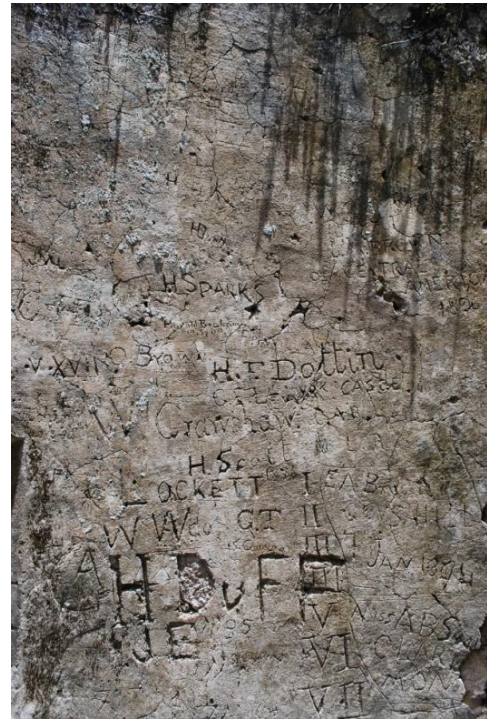
Found on the walls of the castle are graffiti markings which have been etched into the stone walls of the castle (Plate 16 & 17).

Plates 16 & 17. Showing graffiti on the walls of the castle

There are several options that can be used to treat the graffiti on the walls of the structure. They include abrasion to smooth out the graffiti on the wall surface; with this option care must be taken not to damage the ruins by the vibrations and cause the general weakening of the structure. Another option include using fillers to resurface the wall, however, care must be taken to ensure that the mixture is compatible with the stone structure and a final option is to do nothing to remove the graffiti but have it remain as part of the history of the ruin.

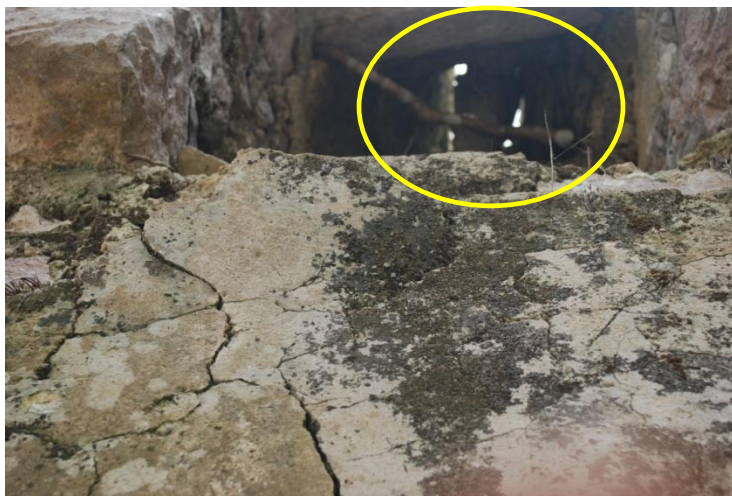
There are also stones which are loose in the structure that may cause damage to visitors if they fall (Plate 18), in addition there are large cracks throughout the structure (Plate 19).

Plate 18. Showing loose stones

The large loose stone that was observed in the chimney should be removed to prevent injury to visitors as well as further deterioration of the building.

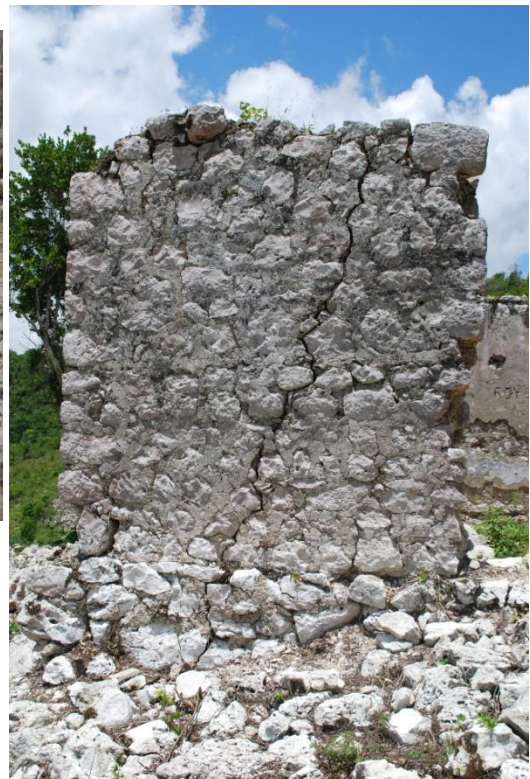
Plate 19. Showing large crack in a wall of the structure

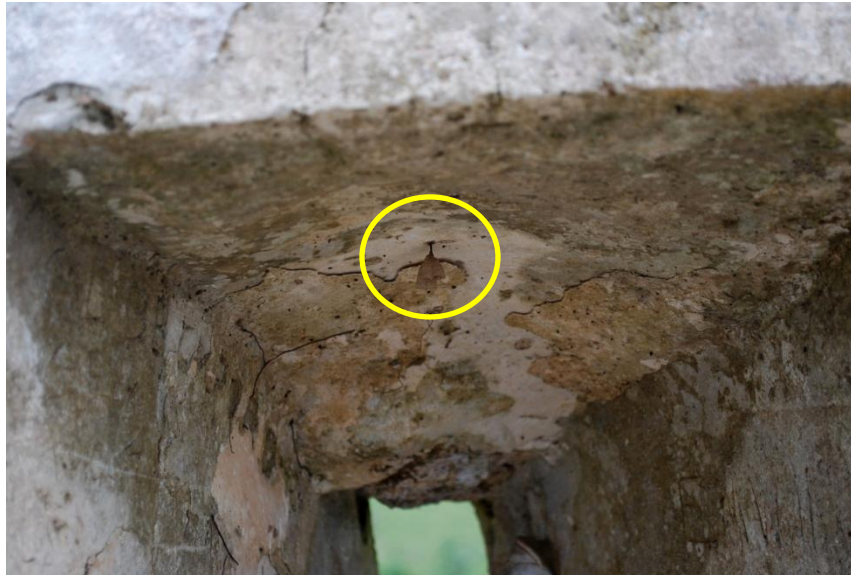
There is evidence of wasps and a hive that was found in one of the loopholes at the front of the castle which gives visual access to the main road (**Plate 20**).

Plate 20. Showing bee hive in one of the castle's loop holes

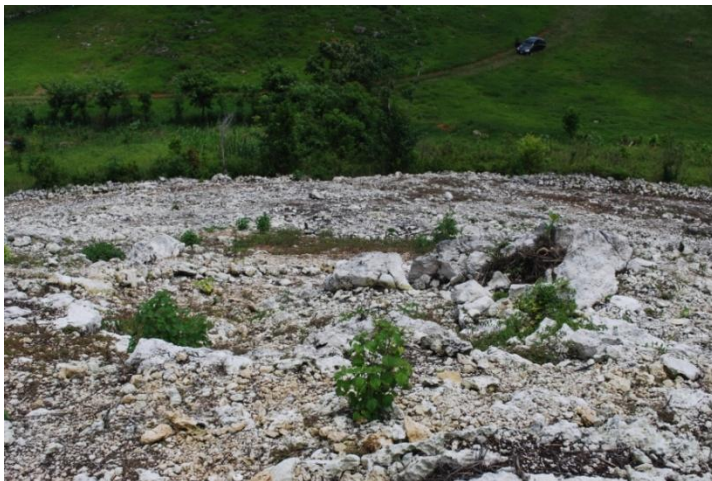
The area where the castle structure is actually located is also quite treacherous and difficult to navigate due to the stony surface (**Plate 21**). There is also some vegetation throughout this area, but it is sparsely distributed. There is at the back of the castle, areas similar to troughs where vegetation such as banana and papaya plants has grown up (**Plate 22**).

Plate 21. Showing stony area around the castle

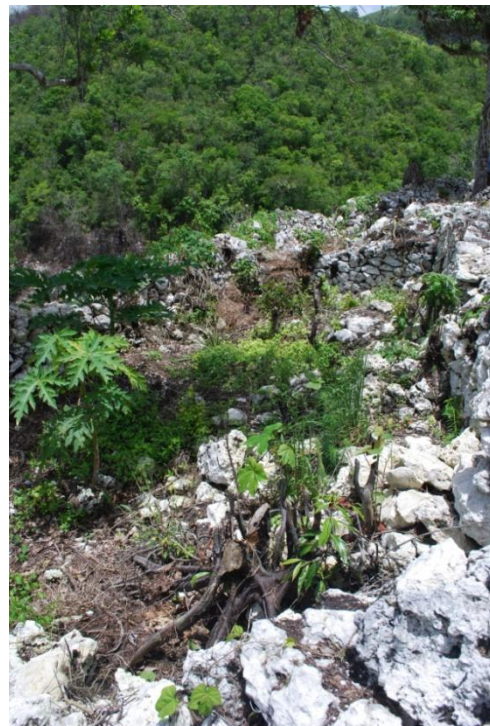
Plate 22. Showing troughs with vegetation

The open troughs that are located at the back of the castle could be filled in with top soil and flowers planted in them to beautify this area of the property (**Plate 41**). The exposed hillside (**Plate 42**) should have flowers and other plant life placed on it to soften its appearance making it similar to the surrounding hills in the area (**Plate 43**).

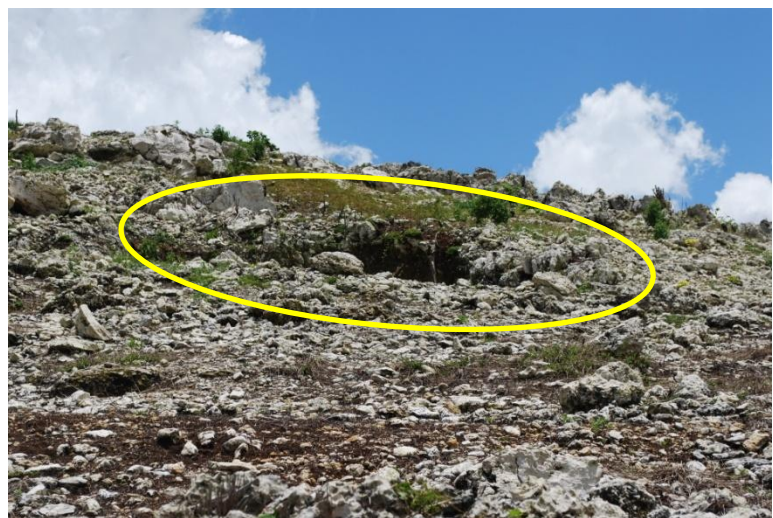
Several artifacts were found on the property. These include several ceramic sherds and two iron artifacts - nail and chain links (**Plate 24**). Found a little way down the hill is what may be one of two sinkholes associated with the property (**Plate 25**).

Plate 25. Showing possibly a sinkhole at the front of property

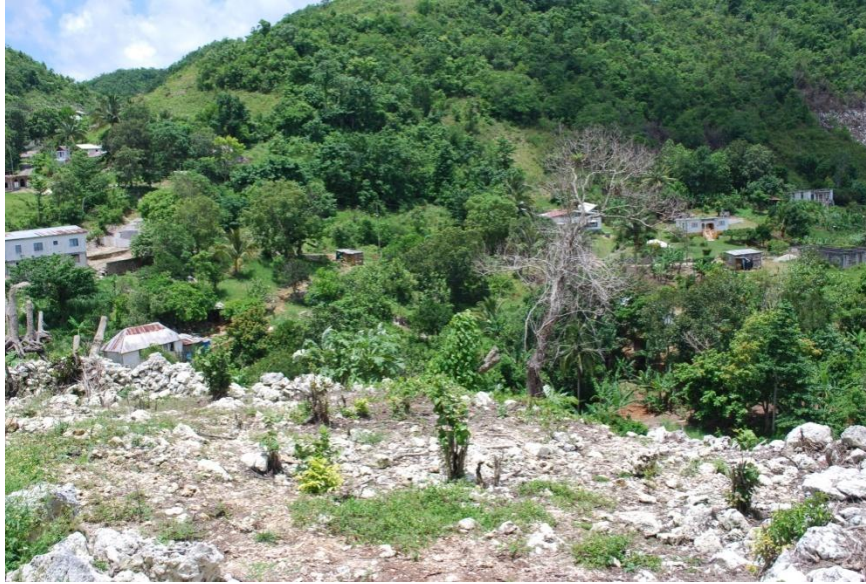
Observed in some areas is that the boundary walls have broken down, which presents a danger to visitors to the site (**Plate 26**). Also, there is a large stone mound that is found just beside the castle structure (**Plate 27**). In addition, there is no electricity or running water to the site.

Plate 26. Showing broken down walls on sections of the property

Broken down walls should be restored using the stones from the property. Also the walls surrounding the castle should to be reconstructed to ensure safety for visitors to the site.

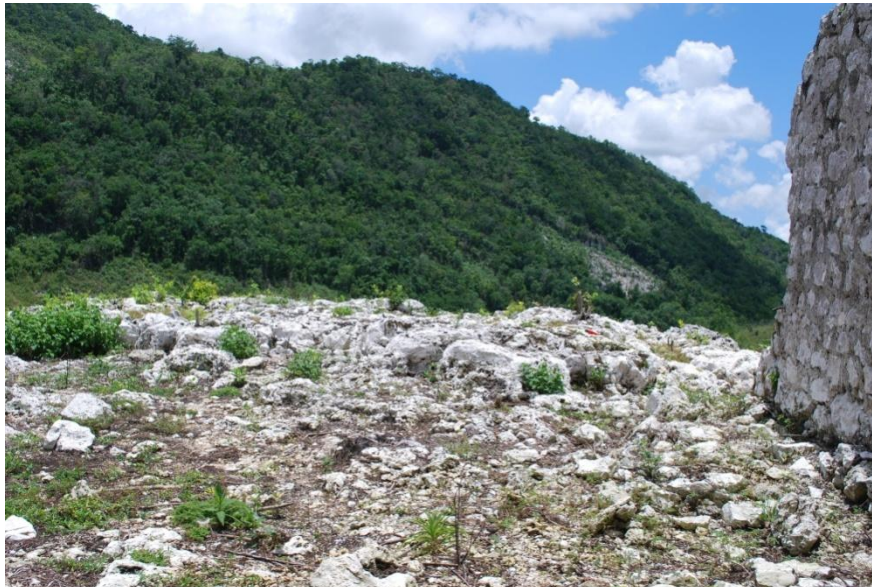
Plate 27. Showing stone mound at the front of the property

The stony mound area opposite the castle on the front of the property should also be landscaped and a simple gazebo (**Plate 39 & 40**) be placed in this area to add to the ambiance of the site, while maintaining its rustic appeal.
