Stokes Hall Great House Development Proposal

Prepared by:
Heritage Preservation Management Unit,
Archaeology Division

Date:
March 2010

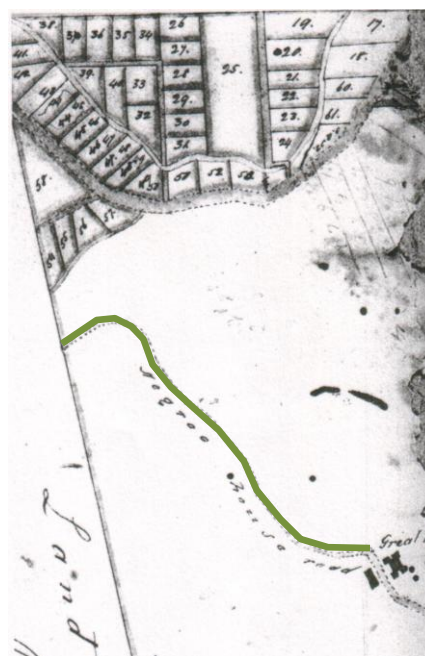
Plan 3. Part of a plan of Stokes Hall Estate, St. Thomas, 1847, by Alexander R. Carter outlining the "Negro House Road"

the 19th century layout. It indicates the slave houses located along the road which led up the slope towards the great house. According to a part of a plan by Alexander R. Carter in 1847, the current route leading to the house was lined with the slave houses and was known as "Negro House Road".

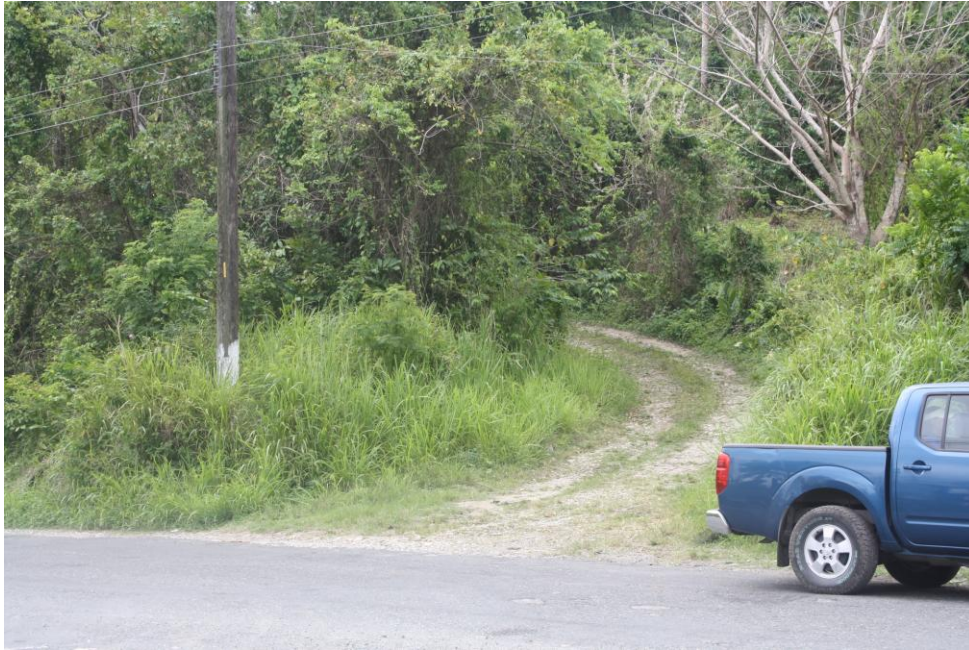
Plate 2. Showing the access road and an absence of directional signs

On observing the Stokes Hall site, several situations that were noted. The approach to the site from Morant Bay via the great house road, it was observed that there were no signs associated with the property (**Plate 2**).

The absence of directional signs was noted. The entrance from the main road is currently hidden by high grass and bushes. It is difficult to see this access road approaching from both directions.

Directional signs should be placed along the St. Thomas road towards the property at the following points to allow for easy access to the site (**Map 1: Proposed Directional Signs to Stokes Hall**):

- Sign at Morant Bay round-a-bout
- Sign indicating right turn at Lysson Intersection
- Sign indicating right turn at Port Morant Shell Gas Station
- Sign indicating right turn at Arcadia Junction
- Sign indicating the Great House access road.
- Welcome sign to the property

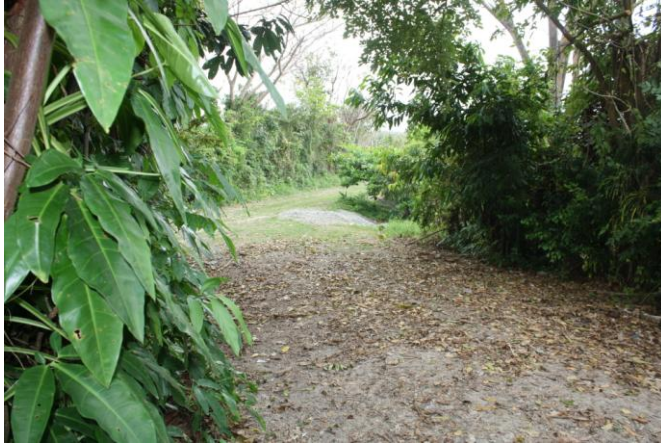
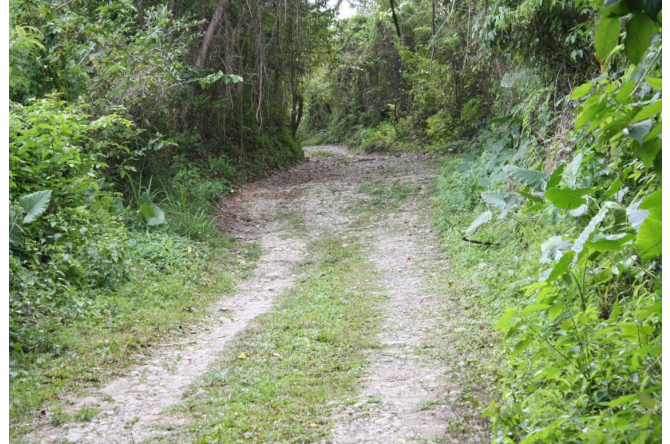
Plates 3 & 4. Showing status of the access road to the site

The access road to the site is narrow and in some areas difficult to negotiate especially when travelling by motor car. Further to this, some areas were observed to be grassy and very bumpy (**Plate 3 & 4**).

The access road towards the property should be widened if possible, to allow for two-way vehicular traffic, as this is the only entrance and exit route to the site. Further to this, there are sections of this road especially at the beginning that makes access to site difficult and so the recommendation is that it be filled so that the road does not deteriorate further and access to the site becomes easier. Another recommendation is that a culvert be placed at the section indicated below in **(Plate 28)**, to allow the run off of water down the hilly slopes, instead of settling on the road.

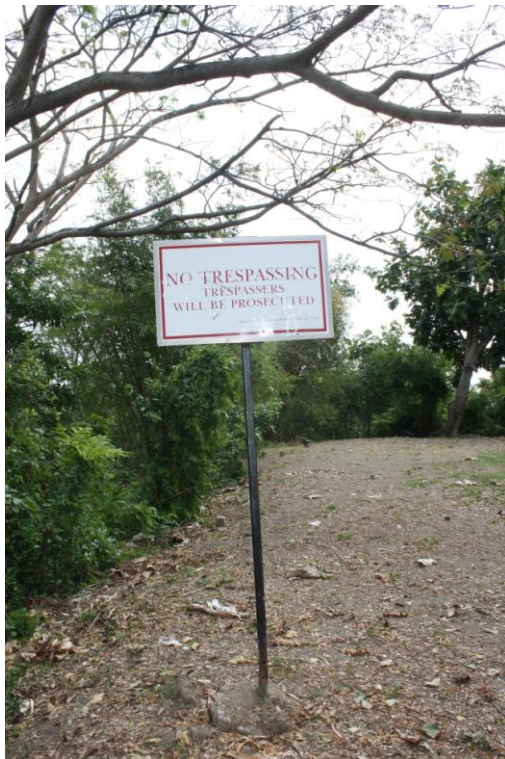
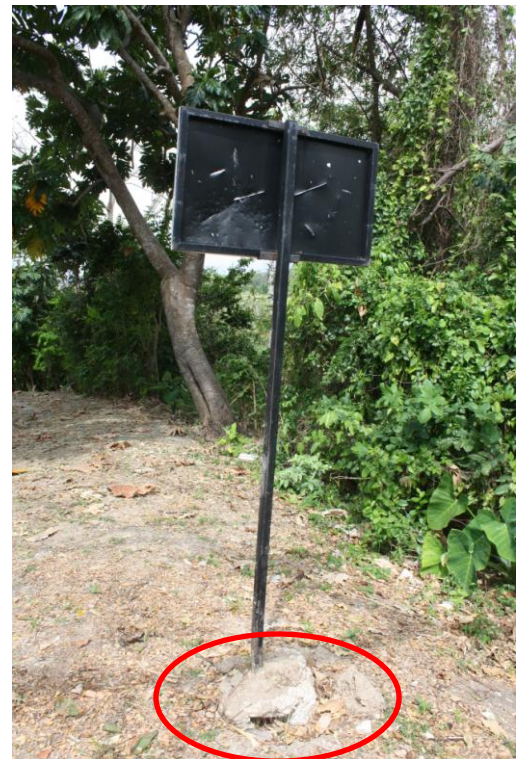
**Plate 5. Showing
No Trespassing
sign**

The site currently has one ‘No Trespassing’ sign which has been defaced by several holes seemingly created by a sharp object. The sign itself is anchored to the ground by a pole but this has been dislodged and is currently very shaky (Plate 5 & 6).

The “No Trespassing” sign at the entrance of the property should be removed and be replaced with a Welcome sign to receive visitors to the property. The current property sign should be removed from the building and a new sign placed at the entrance of the property or the information could be included in the Welcome sign.

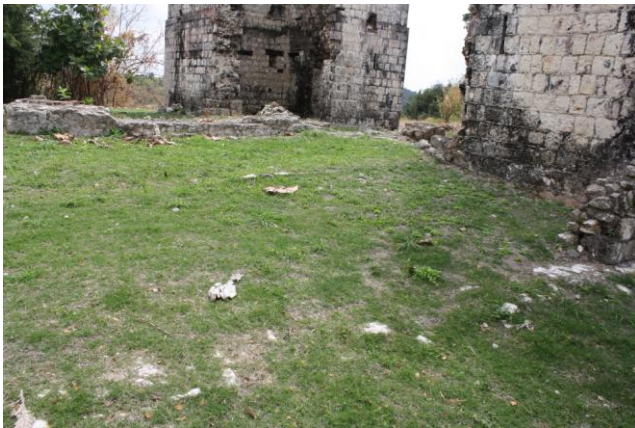
Plate 7. Showing grassy areas

The grounds of the site are generally cleared and dense plant overgrowth, however, there is evidence of dried leaves on much of the area. There are grassy areas (**Plate 7**), several large breadfruit (**Plate 10**) and *Guango* trees (**Plate 9**) and some areas that are without grass and flowers (**Plate 8**). In addition, there is a cane field which is close in proximity to the boundary of the site. The nearness of the cane field (**Plate 11 & 12**) detracts from the site's beauty, especially when the cane has been burnt. There are also a few tree stumps on the property which may result in injury to visitors.

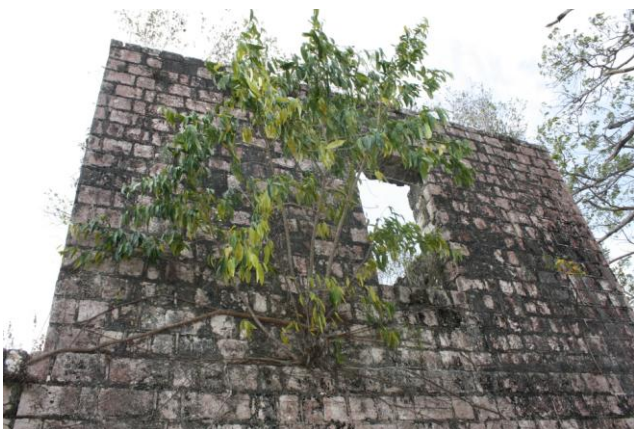
Plate 13. Showing foliage growing from the structure

The great house structure is currently in a good condition. However, there are weeds, trees and small plants with hanging roots projecting from the walls of the structure (**Plate 13**). There are some areas of the house's structure that show deterioration. This is shown in absence of support (**Plate 14**), specifically in the windows and other opened areas where the support beams have rotted (**Plate 15**), fallen out or were removed. Also observed, were large structural cracks within the walls of the structure (**Plate 16**).

In considering recommendations for the great house structure, the suggestions are that the weeds and small trees currently protruding from the structure should be removed with the assistance of the Conservation Unit and outside agencies that can provide assistance, such as Forestry Department.

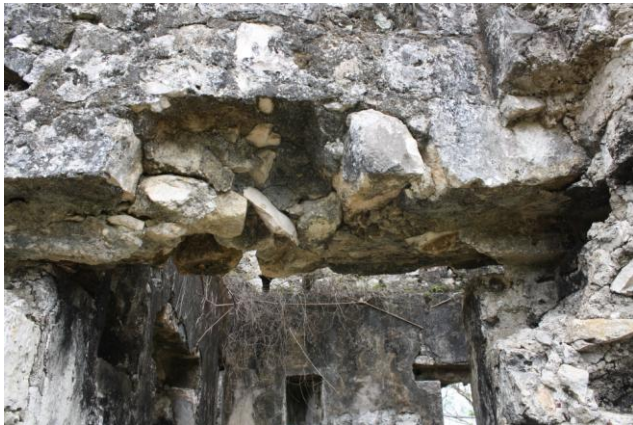
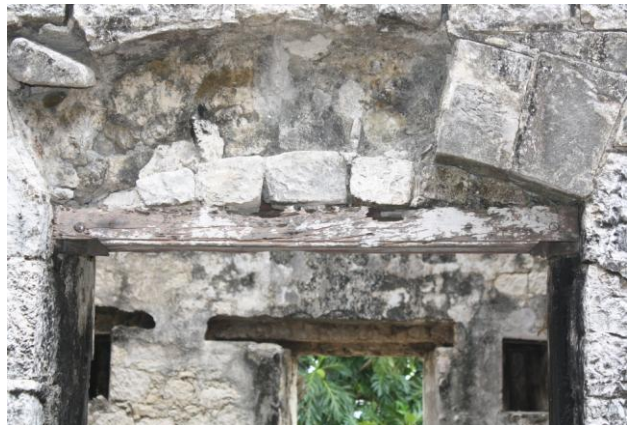
Plate 17 &18 Showing stones breaking away

The stone in some of these areas have fallen out or on the verge of falling out (**Plate 17 & 18**). Between the two main parts of the structure and to the left of the structure the foundations of other sections of the great house can be seen through the grass which has grown up around it (**Plate 19 & 20**).

The recommendation for loose stones observed on the building is that these sections be restored to prevent injury to visitors and further deterioration of the structure. This is also the case for the areas that exhibit cracks in the walls, these areas should also be restored to prevent any further deterioration of the structure.

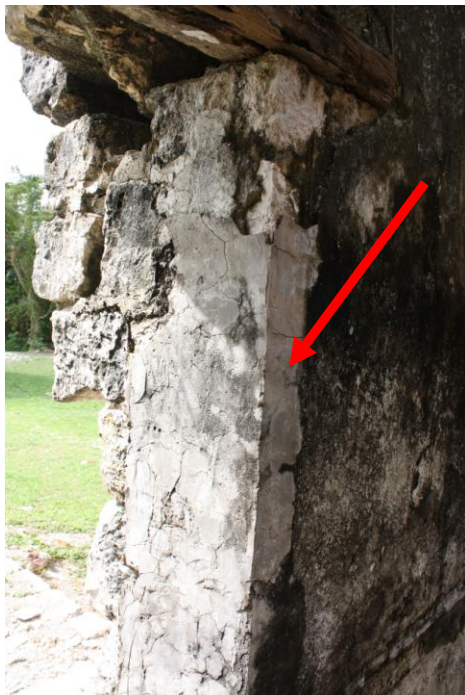
Plate 21. Showing new repairs

There is evidence of repairs that were done in the past, as new applications of cement on the structure were observed (**Plate 21**). A chicken was seen nesting in a hole of the structure (**Plate 22**).

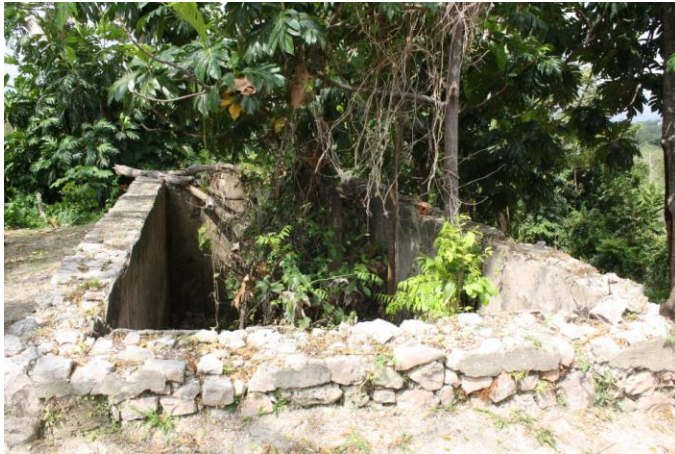
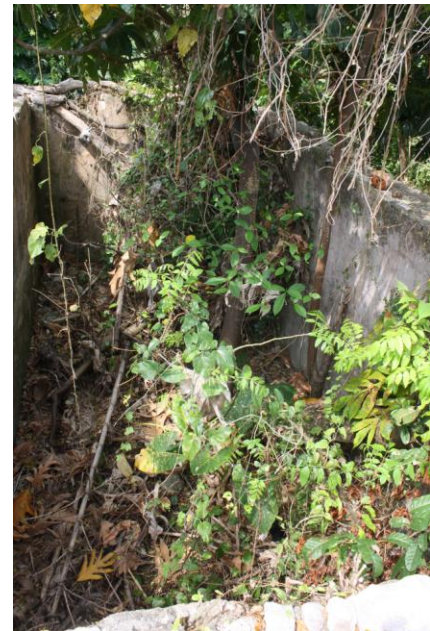
Plates 23 & 24. Showing water storage structure

Located towards the entrance of the property is a large open stone feature which may have been used for water storage in the past. Currently, there are trees and other plants growing within this structure (Plates 23 & 24).

The water tank (**Plate 38**) located near the entrance of the property should be cleared of all undergrowth and trees. It could also be sealed off and a gazebo (**Plate 39**) constructed on it. The gazebo would be painted white to allow couples to use this area for weddings. The steps to the gazebo could be constructed from the cut stone rubble (**Plate 40**) found on the property as well as to use them to create a boundary around the flower bed near to the gazebo (**Plate 41**). A smaller gazebo could be placed at the southeast corner of the property which would have a view of the valley below (**Plate 42**).

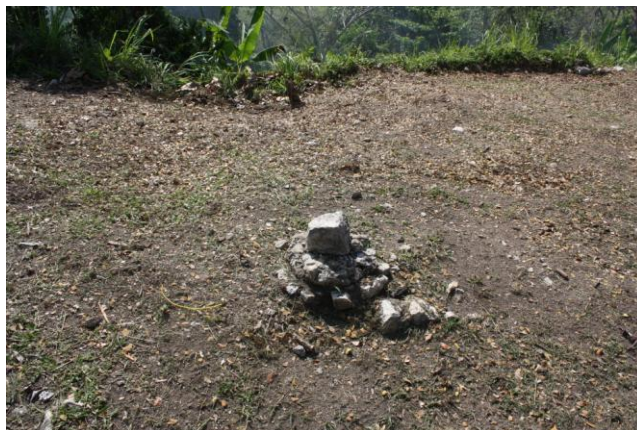
Plates 25. Showing the remains of foundations at the back of the property

At the back of the property there is evidence of a boundary wall, but currently it is obscured by dense plant growth. There is also evidence of foundations of what seems to be remains of columns and rooms, but are currently not exposed enough to be clearly defined (Plates 25 & 26).

The foundations (**Plate 36 & 37**), as shown below, located in the north and southwest corners of the property need further clarification, and as a result, an archaeological evaluation is required to allow for a clearer interpretation of the site. After the evaluation, the structures should be exposed to show more of the historic foundations.

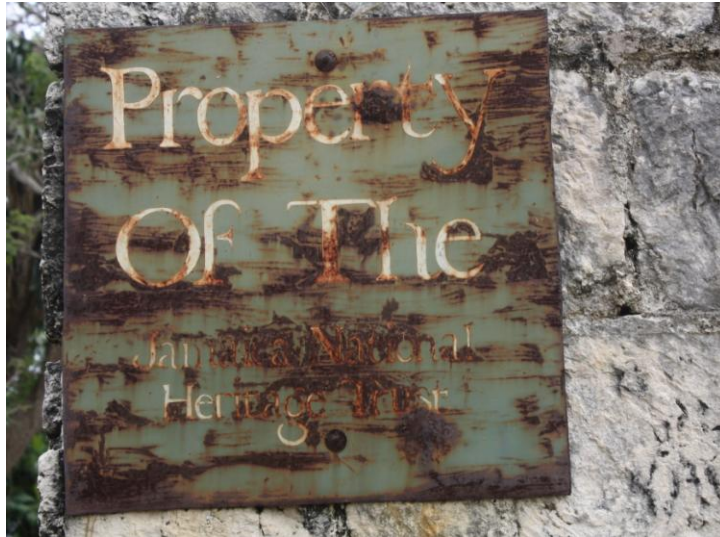
Plate 27. Showing Property of JNHT sign

There is a sign attached to the building indicating ‘*Property of the Jamaica National Heritage Trust*’, that is not very clear as most of the words are now rusted over (Plate 27).
