Stewart Castle Development Proposal

Prepared by:
Heritage Preservation Management Unit, Archaeology Division

Date: **August 2010**

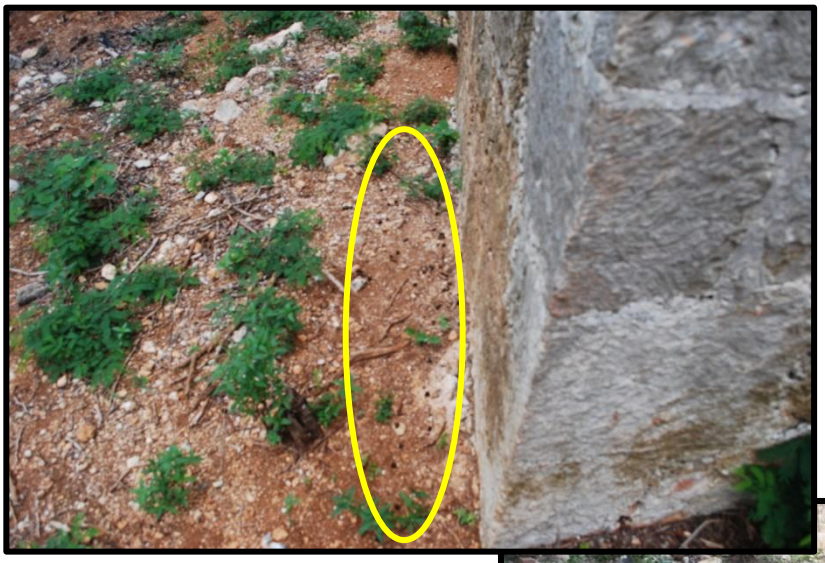
There is evidence of goats and other animals roaming the property due to the excrement found throughout the site (plate 15). There is also a pumpkin vine located at the foundations near the red birch tree (plate 16) and also at the north-west section of the property a bed of white periwinkle (plate 17).

Plate 15: Showing goat excrement

Plate 16: Showing pumpkin vine at the base of foundation

Plate 17: Showing periwinkle bed

foundation can be built up by at least 1 ft using stones from the property and flowers planted around the tree creating a small garden. Therefore, there should be no further removal of the stones from this section. Also, the pumpkin vine growing in this area should be removed. Trees throughout the property that have been cut down which are showing signs of re-growth need to be allowed to grow as they will provide shade. Shade trees such as the Poinciana tree, Tamarind or Guango, some of which are already present on the site and would add beauty to the natural environment of this property (plates 48 & 49) should be planted in the bare areas.

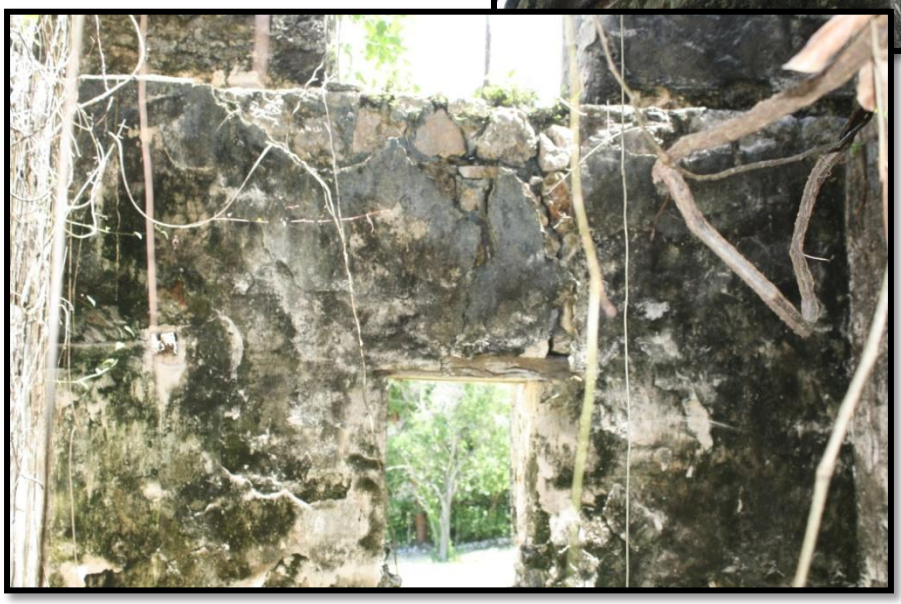
Plate 37: Showing hanging roots from privy (out building)

The small outbuilding described also as a privy according to Digital Archeological Archive of Comparative Slavery (DAACS's) 2007 research, located at the north-east of the castle shows plant life growing out of the top and cracks in the building as well as hanging roots from the top (plates 35, 36 & 37).

The red birch tree growing from the top of the privy along with other plant life should be removed. In addition, the aloe vera and cacti beside the structure also needs to be removed and flowering plants planted around the base in and around the area where the foundation is located. Also, the wall and window needs to be stabilized due to the large cracks on the wall to ensure visitors safety.

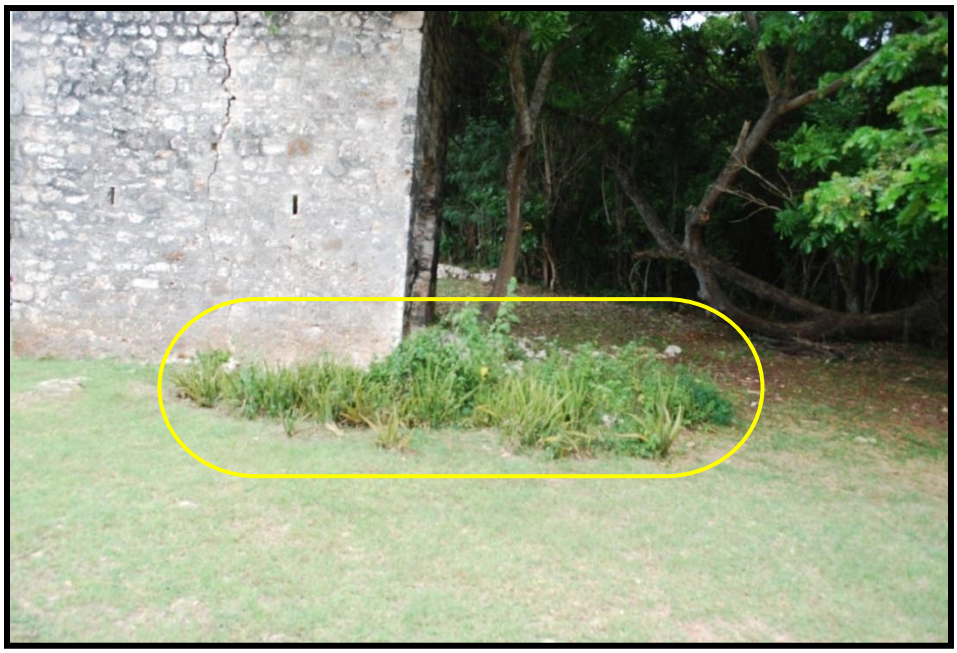
Plate 40: Showing area with Aloe Vera and cacti

Found around the base of this structure is a bed of Aloe Vera and cacti. It is important to note that the property has no lighting or running water (plate 40).
