Edinburgh Castle Development Proposal

Jamaica National Heritage Trust

**World Heritage Unit,
Archaeology Division**

July 2010

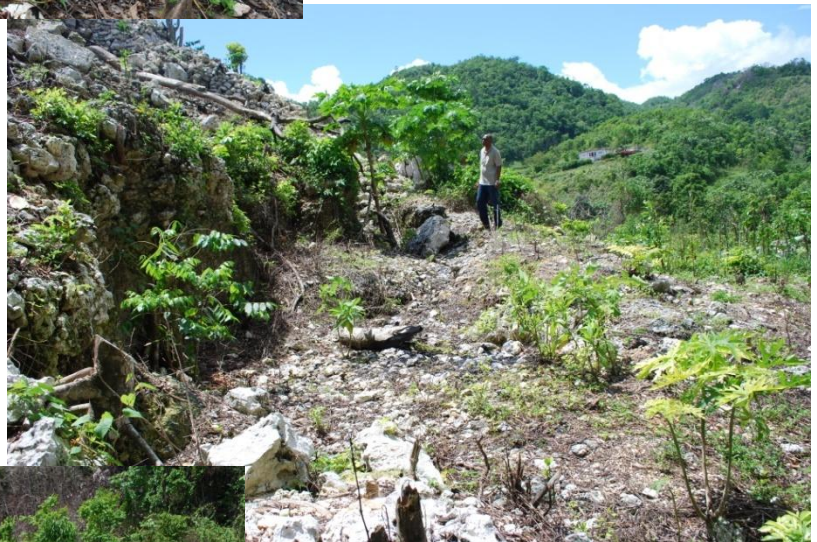
Plate 8. Showing alcove

Also observed in this area specifically to the left of the entrance gate, rubbish has been dumped and some has been burnt while other pieces have been left as litter (**Plate 7**). There is in this area, a small alcove where some of the plant-life specifically trees has been removed (**Plate 8**). This section also leads to an area where there is evidence that farming has taken place as yam, banana and papaya plants were observed (**Plate 9**).

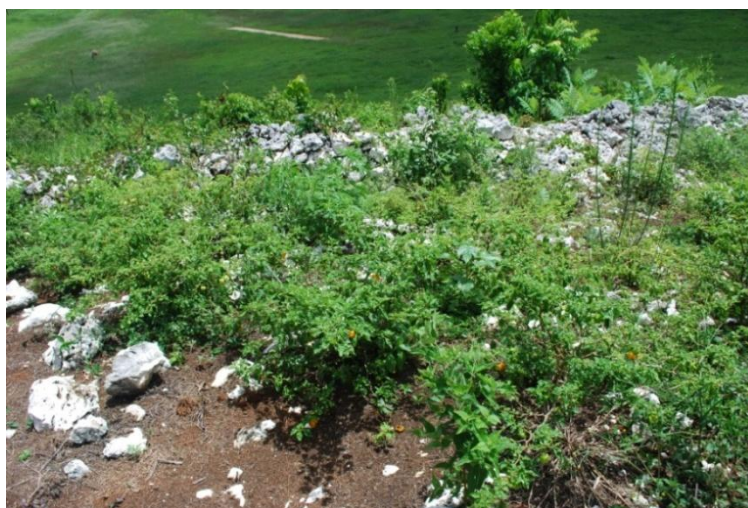
Plate 12. Showing pepper trees

At a particular juncture of the pathway there are several pepper trees, which have been planted in a small area off of the pathway (**Plate 12**).

The area along the walkway where several pepper trees (**Plate 12**) are planted should be landscaped and planted with several colourful indigenous flowers (**Plate 35**) to beautify this area of the site.

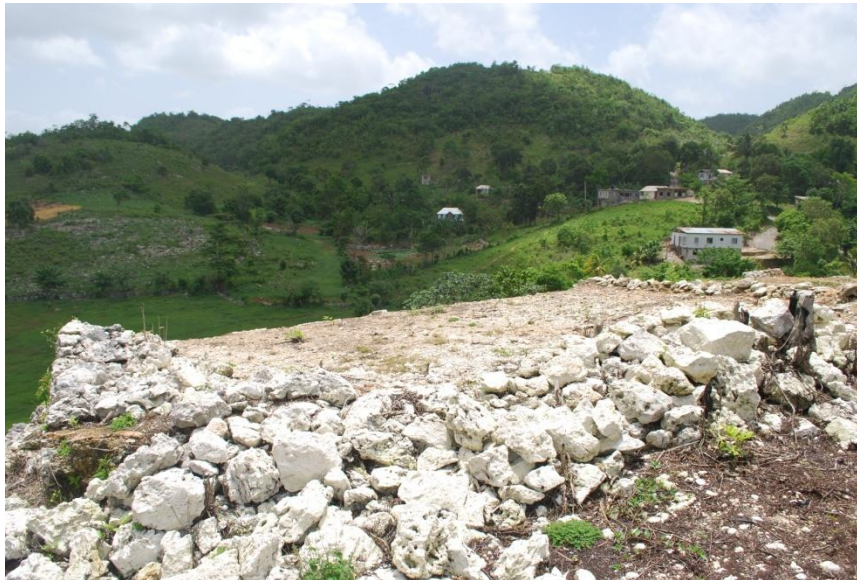
Plate 23. Showing foundations at the front of castle

It was further observed that there are two areas towards the front of the castle that seem to be foundations (**Plate 23**).

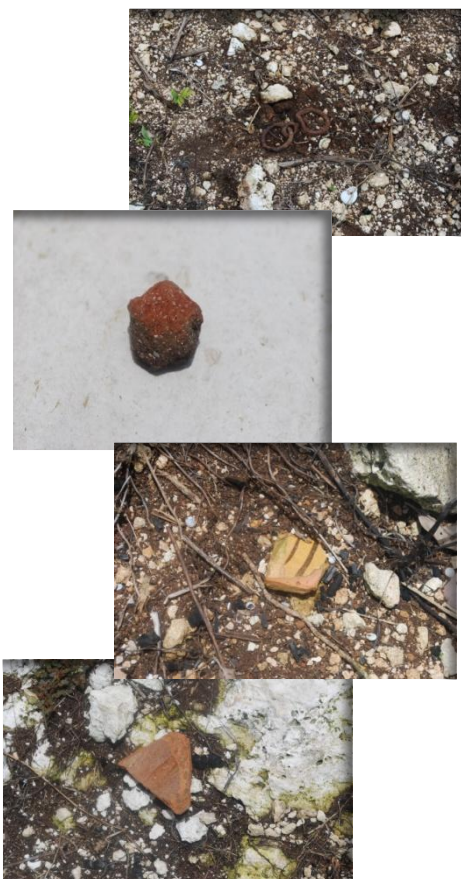
Plate 24. Showing ceramic and iron artifacts

Several artifacts were found on the property. These include several ceramic sherds and two iron artifacts - nail and chain links (**Plate 24**). Found a little way down the hill is what may be one of two sinkholes associated with the property (**Plate 25**).
